SITE NUMBER: H-L1-02 LOCAL NAME: Unnamed

NORTH COAST OFF CHANNEL SITE INVENTORY DATA

RIVER SYSTEM: Hoh River

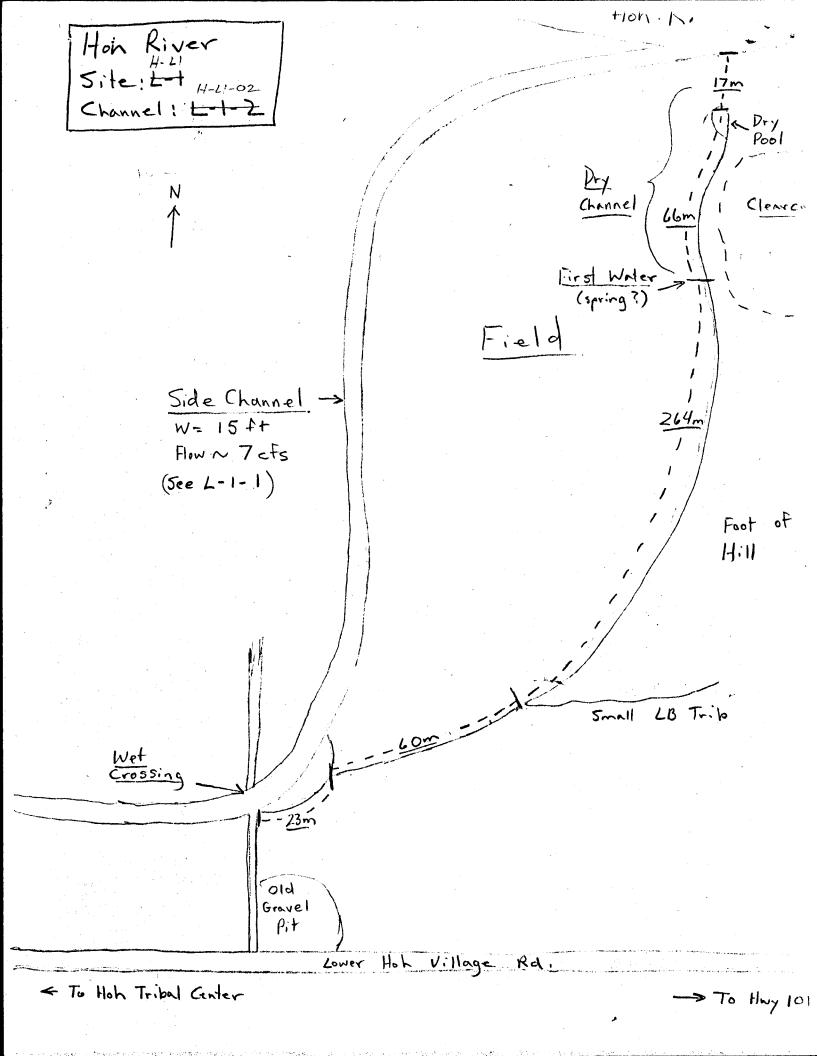
290 000 FEET 124°22'30" 6825 2286 DESTRUCTION ISLAND QUADRANGLE WASHINGTON – JEFFERSON CO. 7.5 MINUTE SERIES (TOPOGRAPHIC) NWA DESTRUCTION ISLAND IS QUADRANGLE
395 70 813W (8) Lower Hon Rd 1 120 000 FEET ** ** ** 95 Ruby . Beach Hoh River Site: tot H-LI Site Map
